Construction Issues

Alabama Seminar
2013

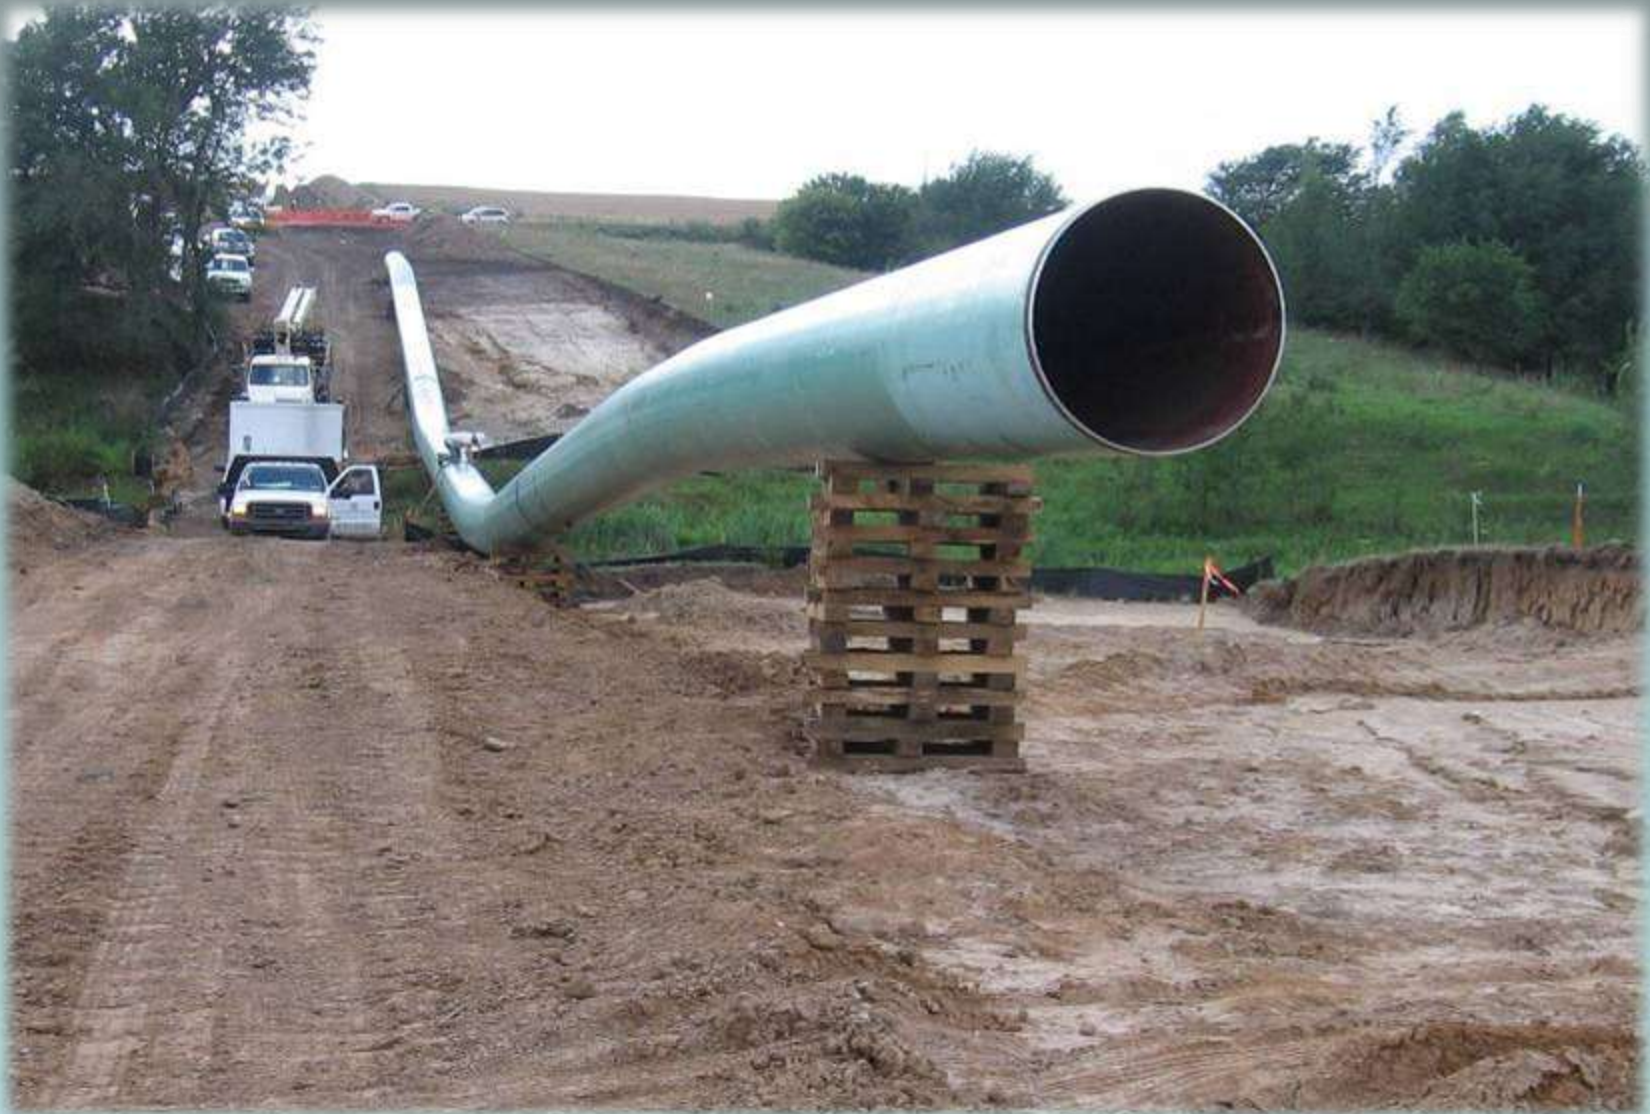
Pipe on skids can move and fall.
You want to park where!

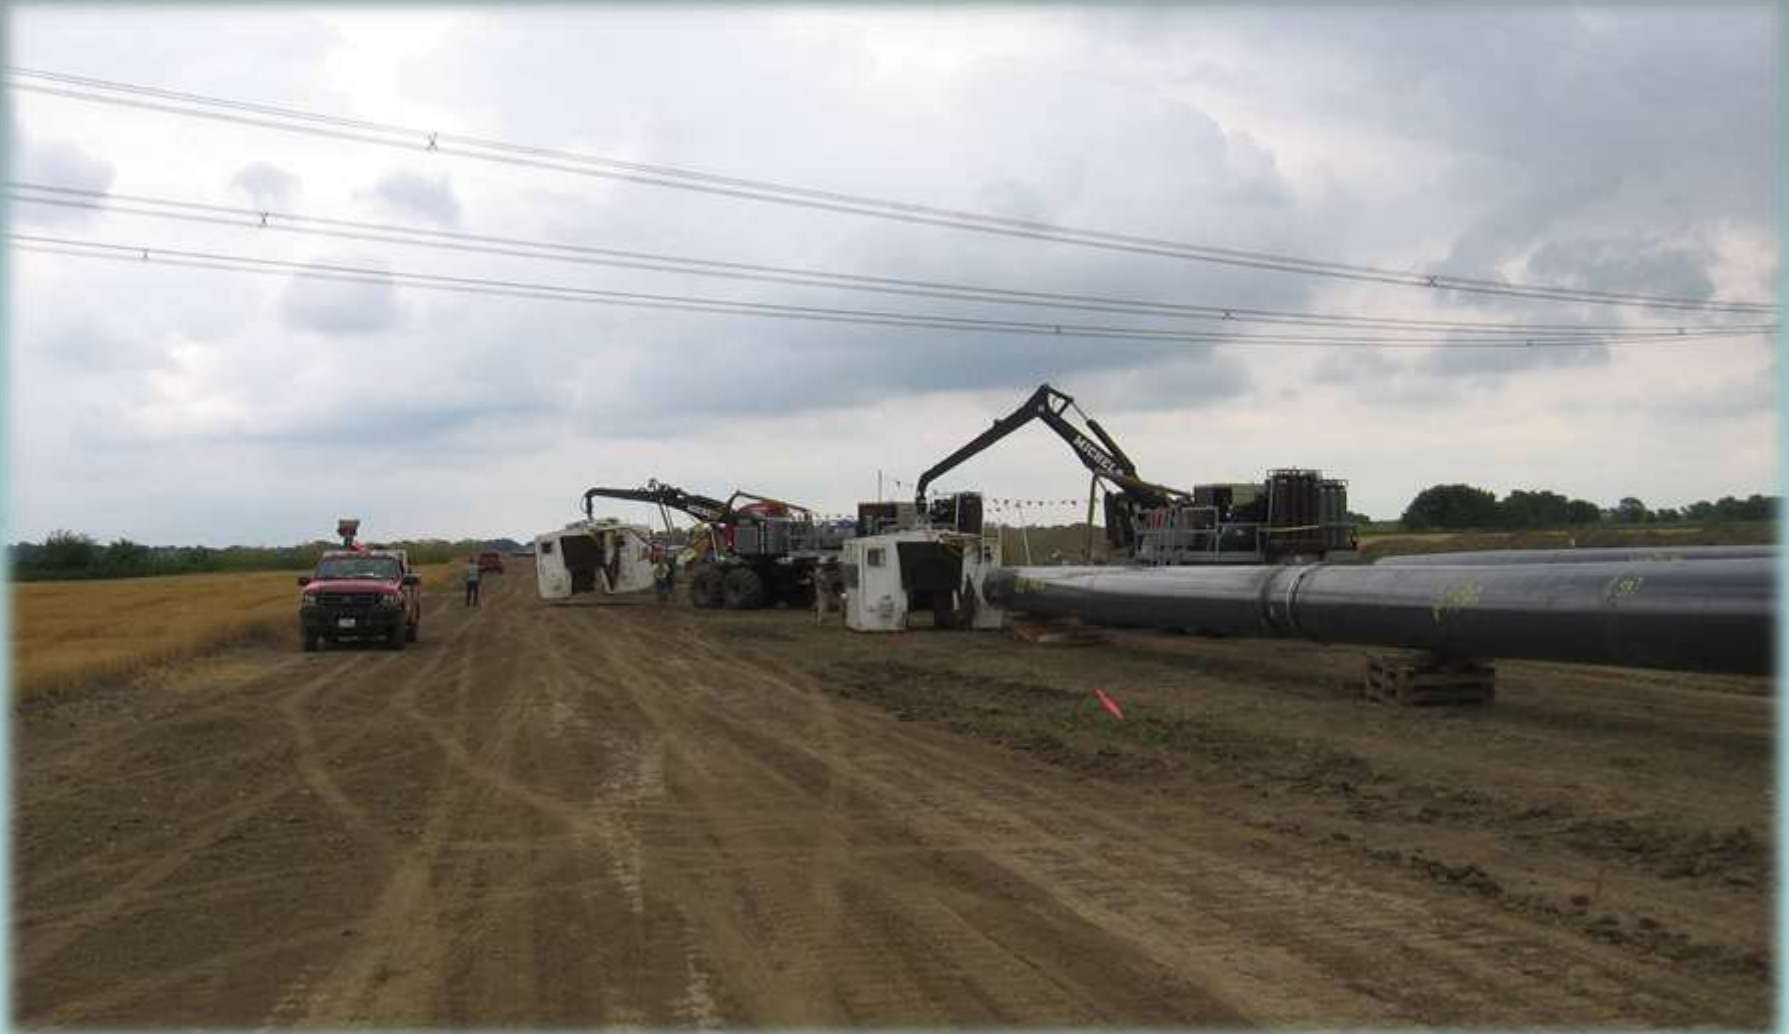
Do you want to be under these wires or near this equipment?

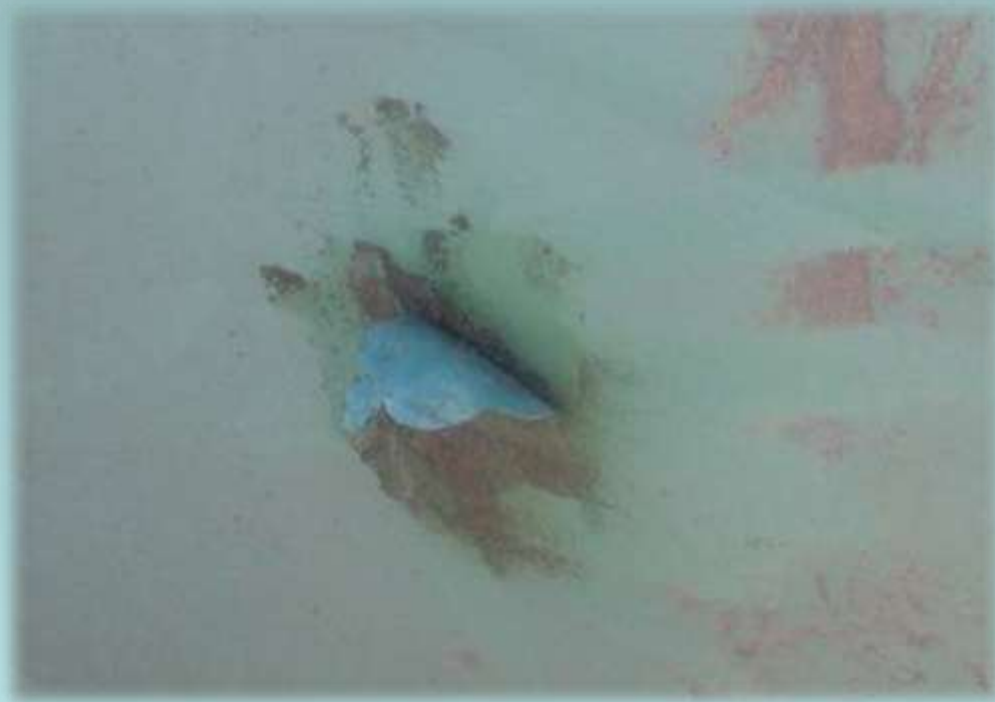
- Poor application practices.
- Soil stress can remove poorly installed patch stick repairs.
- Heating the patch stick and dripping the product on the coating holiday is not acceptable.
- The photo shows a poorly adhered patch stick repair. This was found upon uncovering a newly built pipeline.

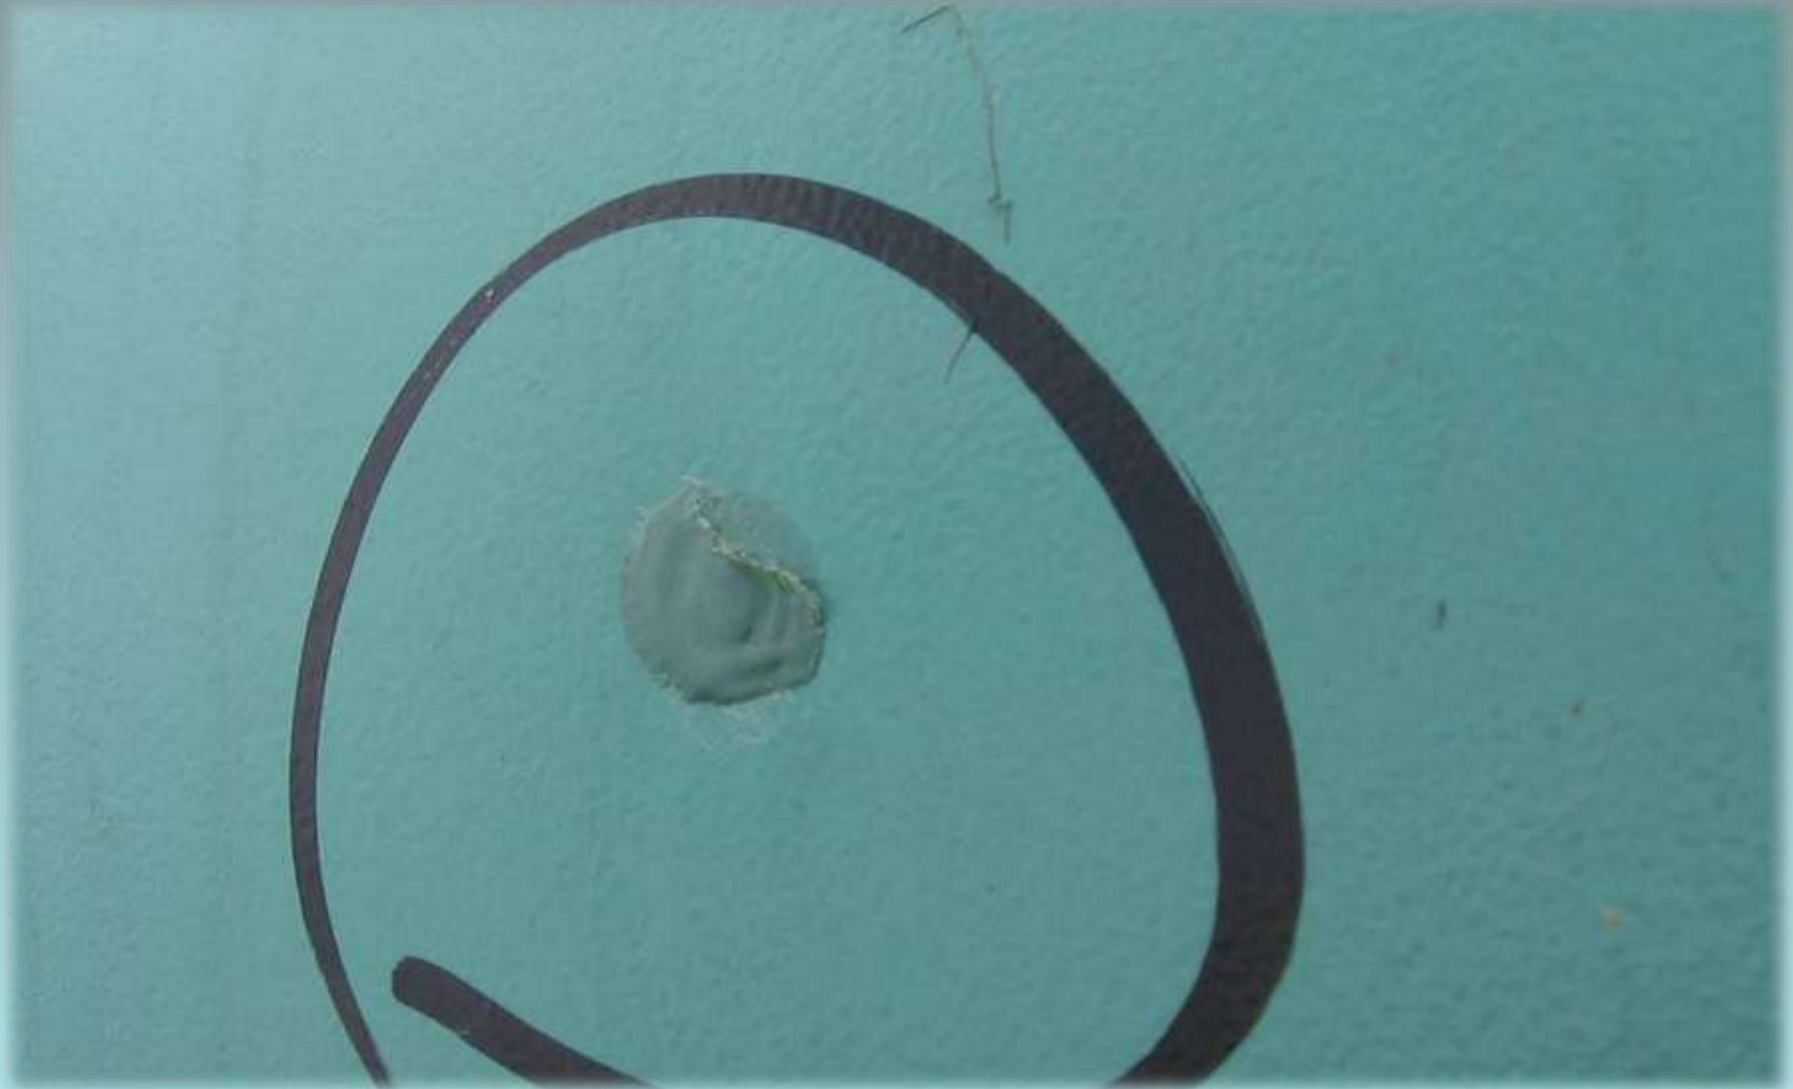
Manufacturer's procedures for patch stick application must be followed. The photo shows a fingernail scratched off applied patch stick repair

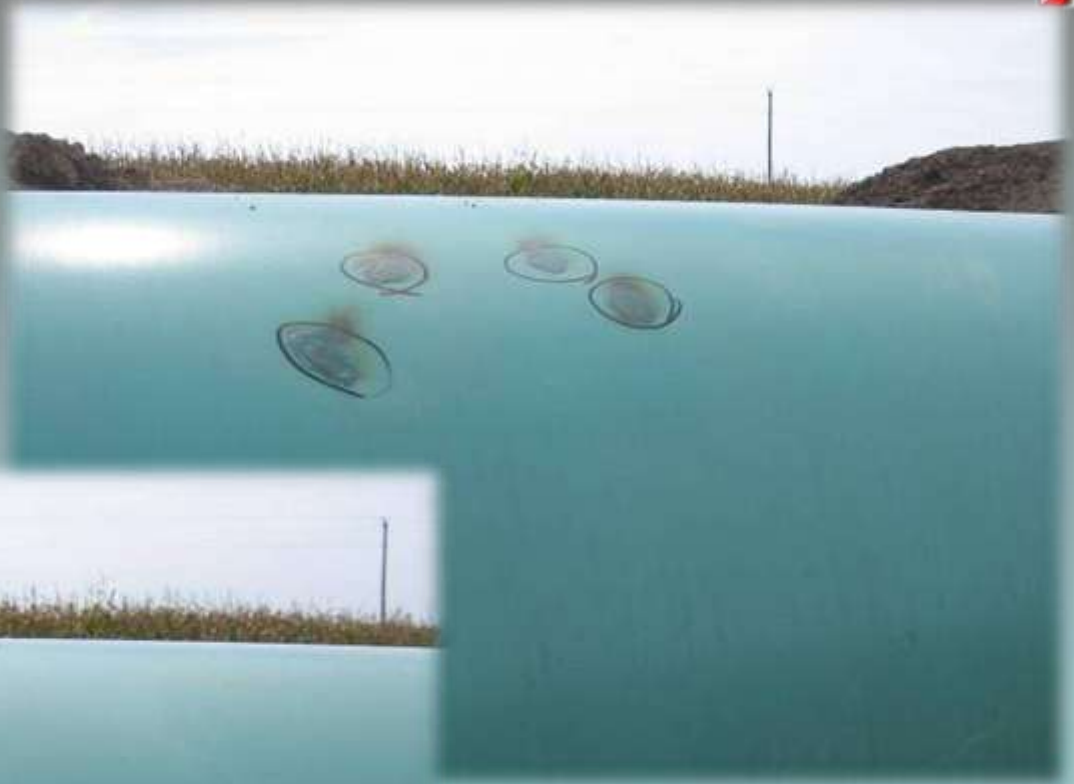
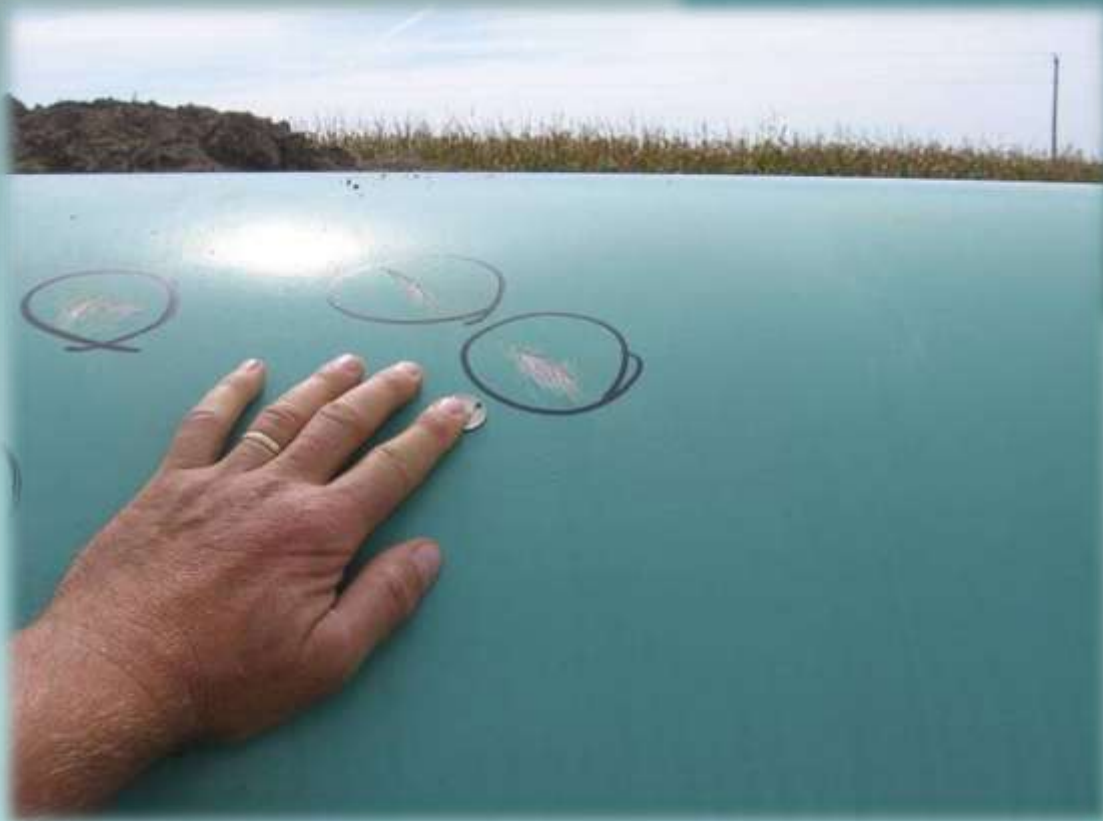
Patch Sticks are only for
pinhole or abrasion repair.
2 part epoxy should have
been used.

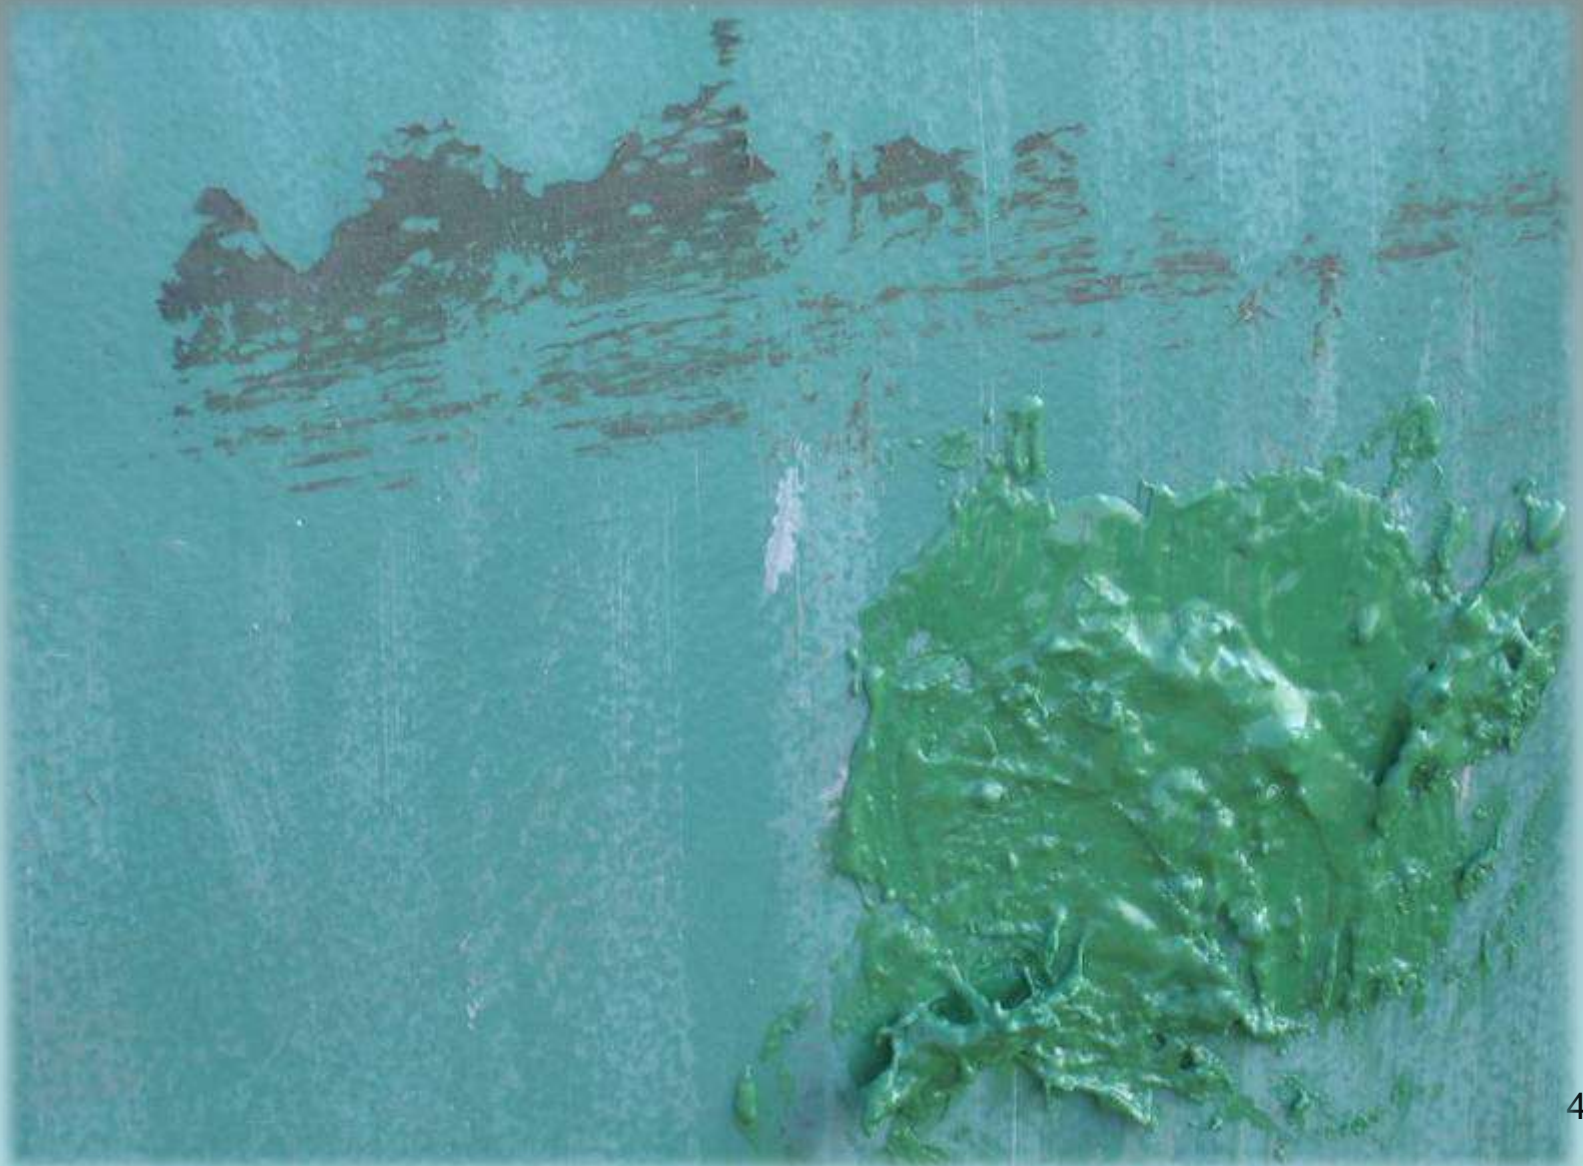
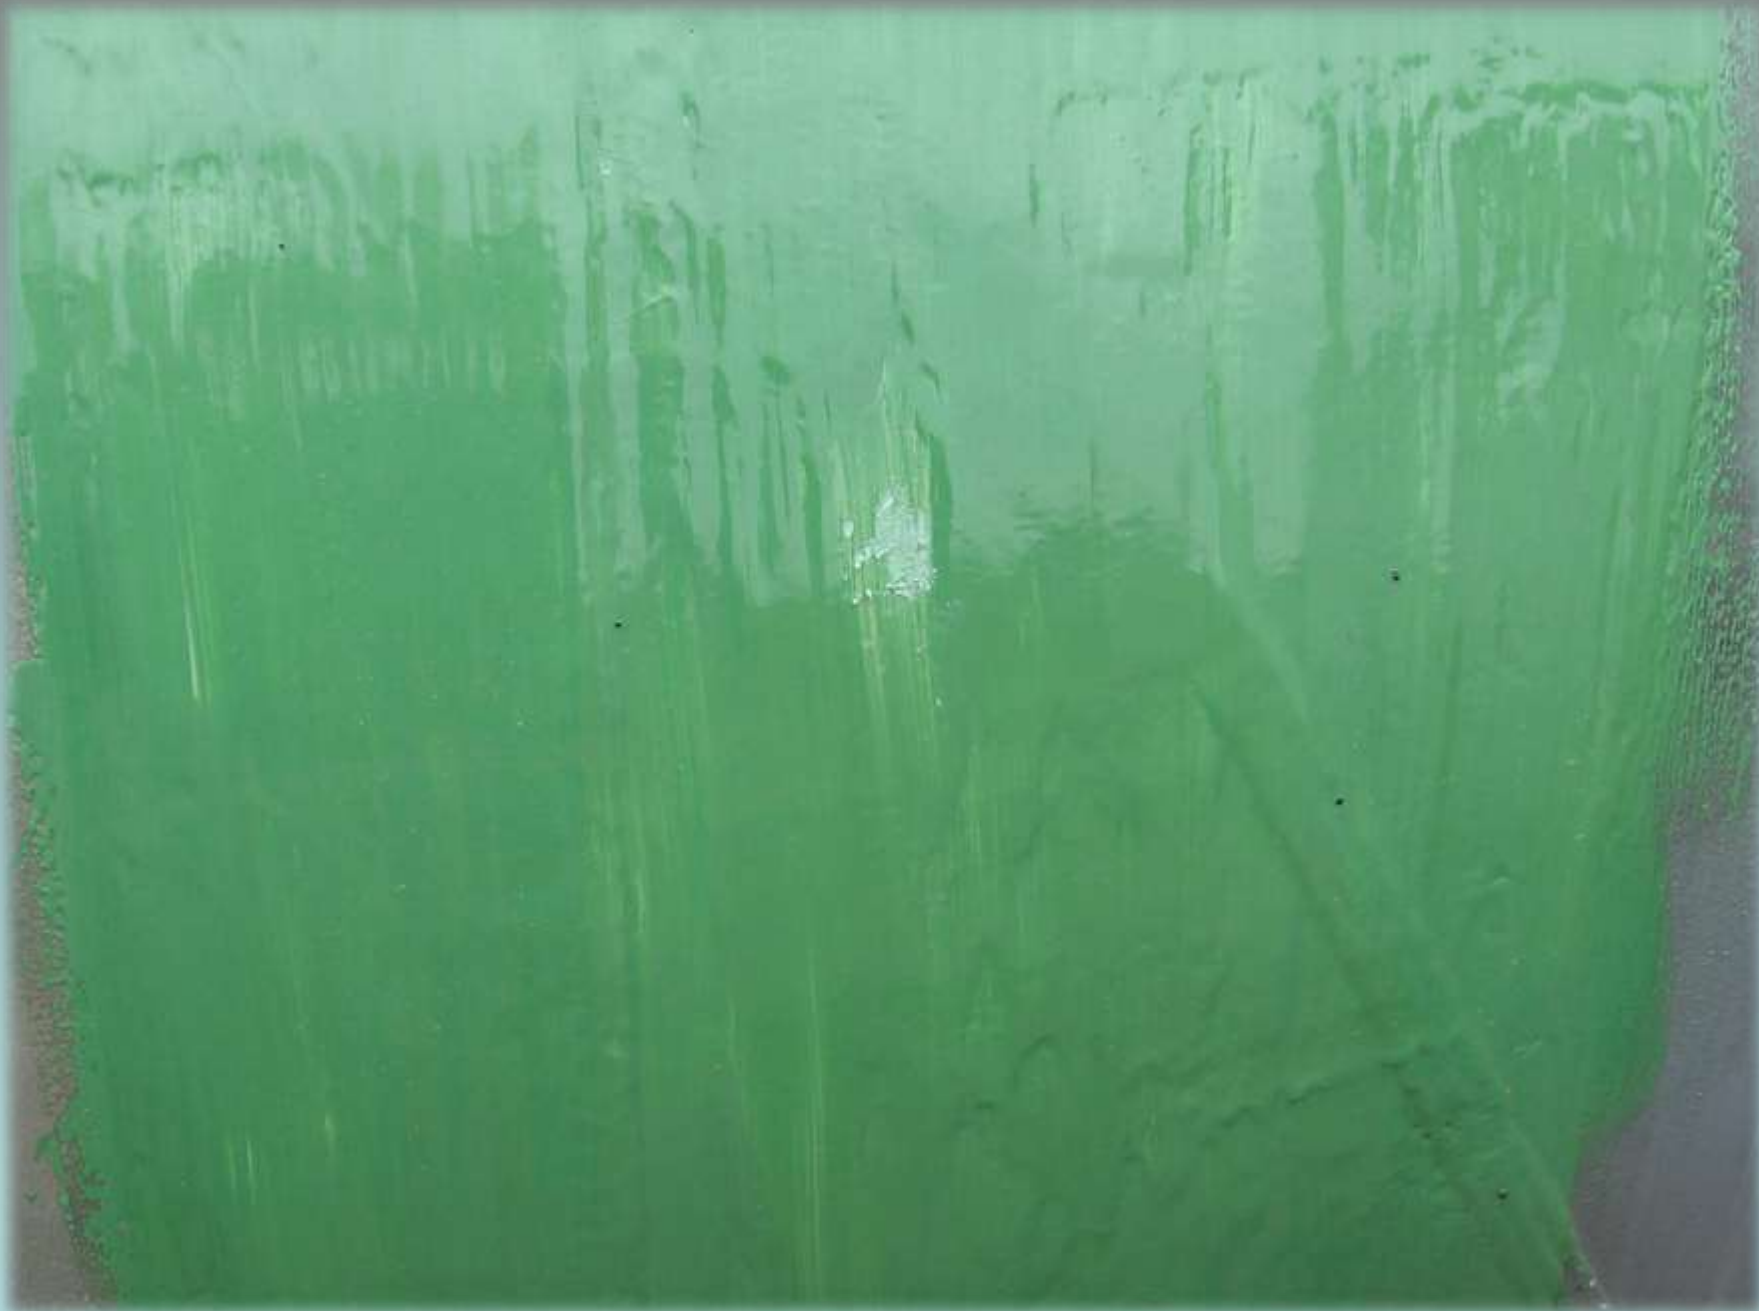
2 Part Epoxy

- Follow manufacturers instructions
- Preparation required (Sanding = anchor pattern)
- Thoroughly mix product
- Use promptly
- If products starts to cure before application the repair presents the appearance of the next slide

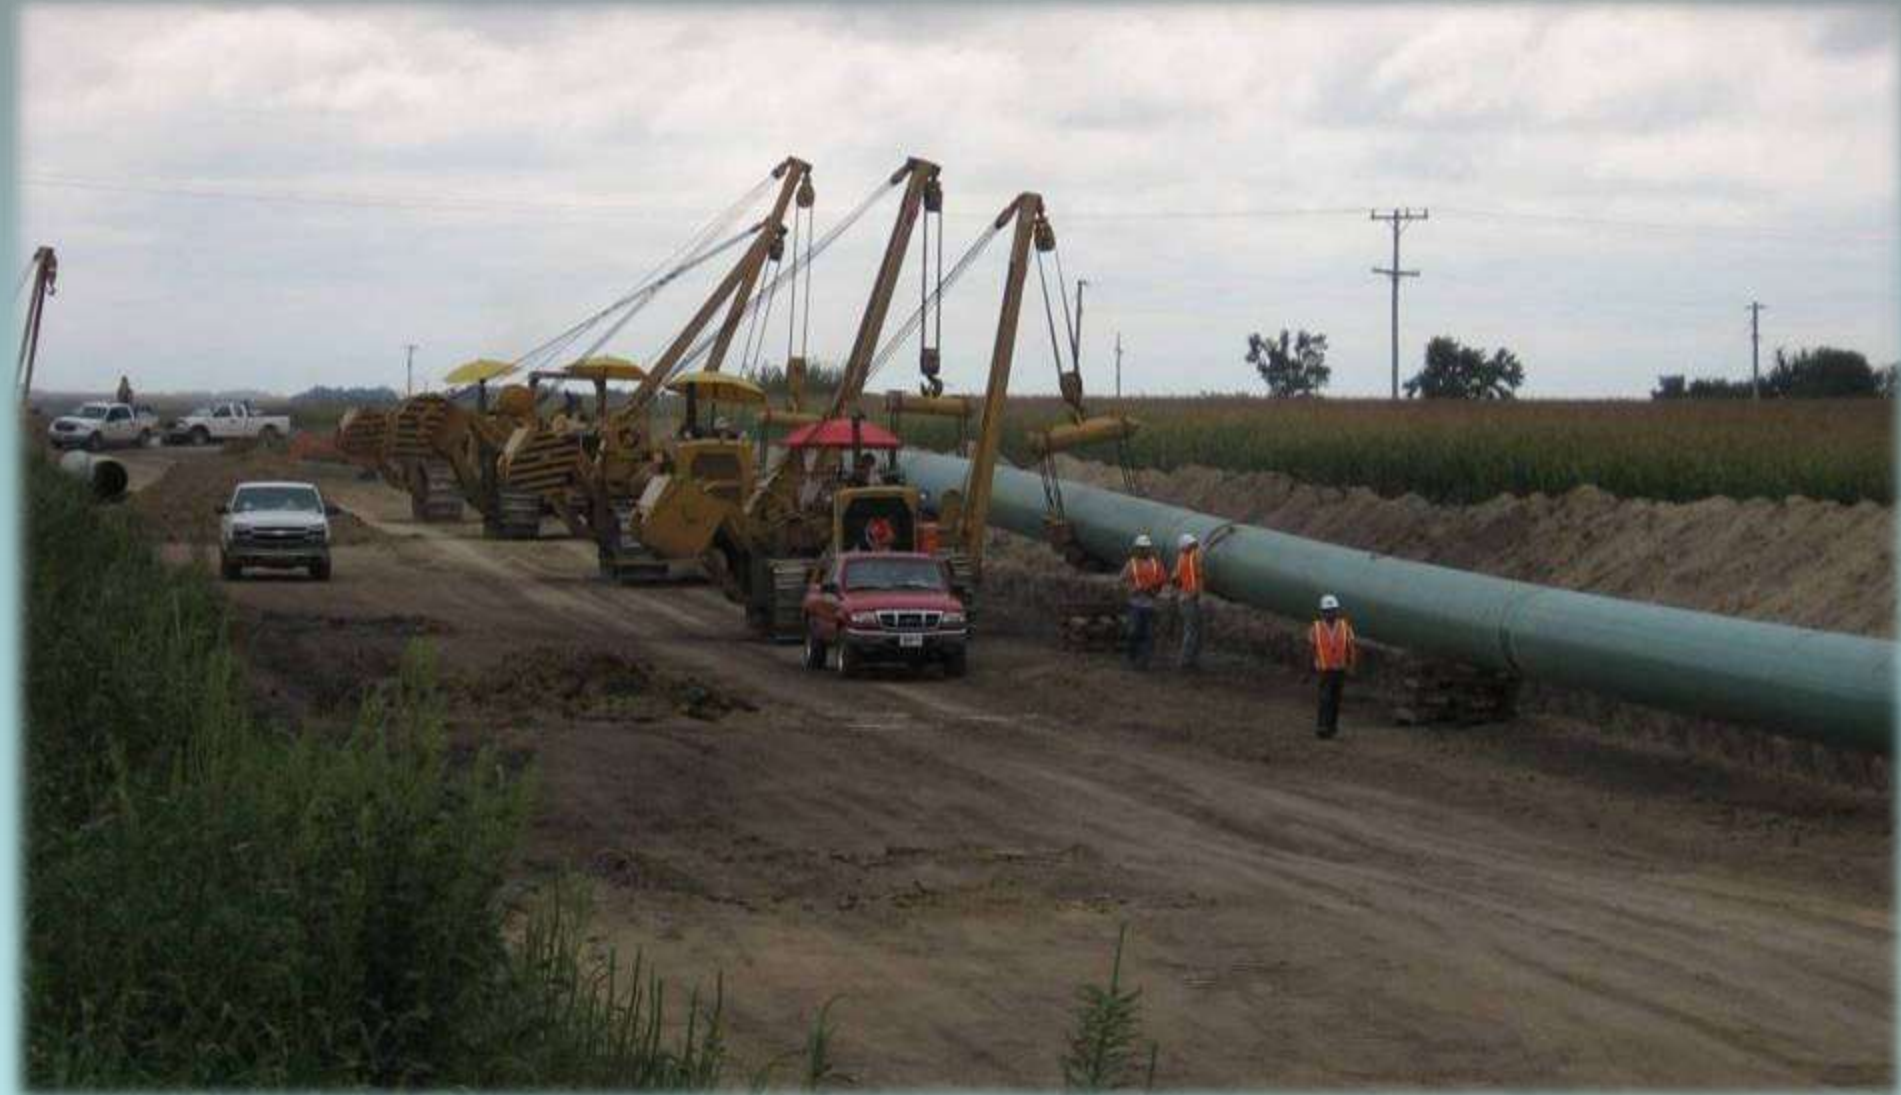
Are the workmen finding coating holidays? Do the workmen operating the jeep have time to find and repair coating holidays?

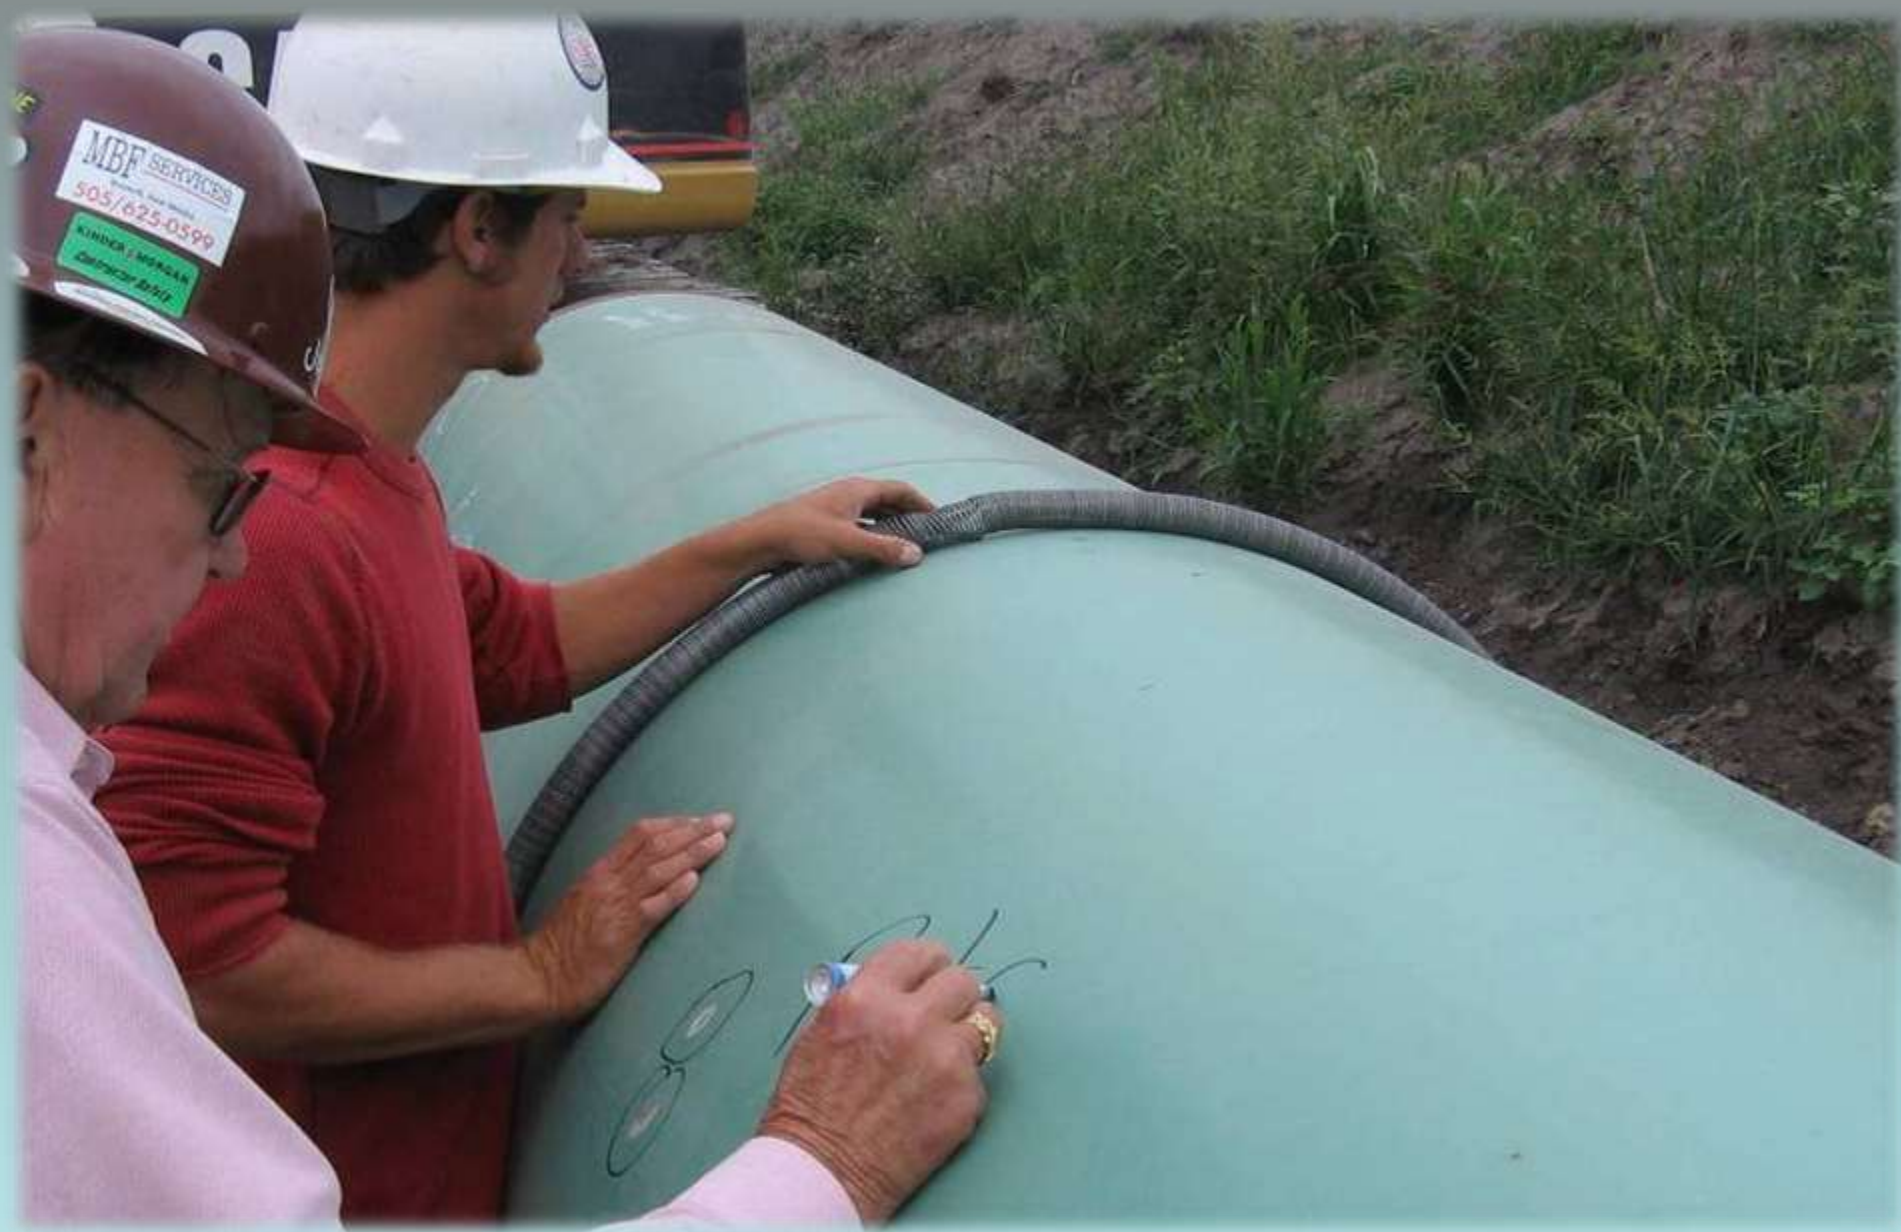
A bent jeep spring can miss coating holidays

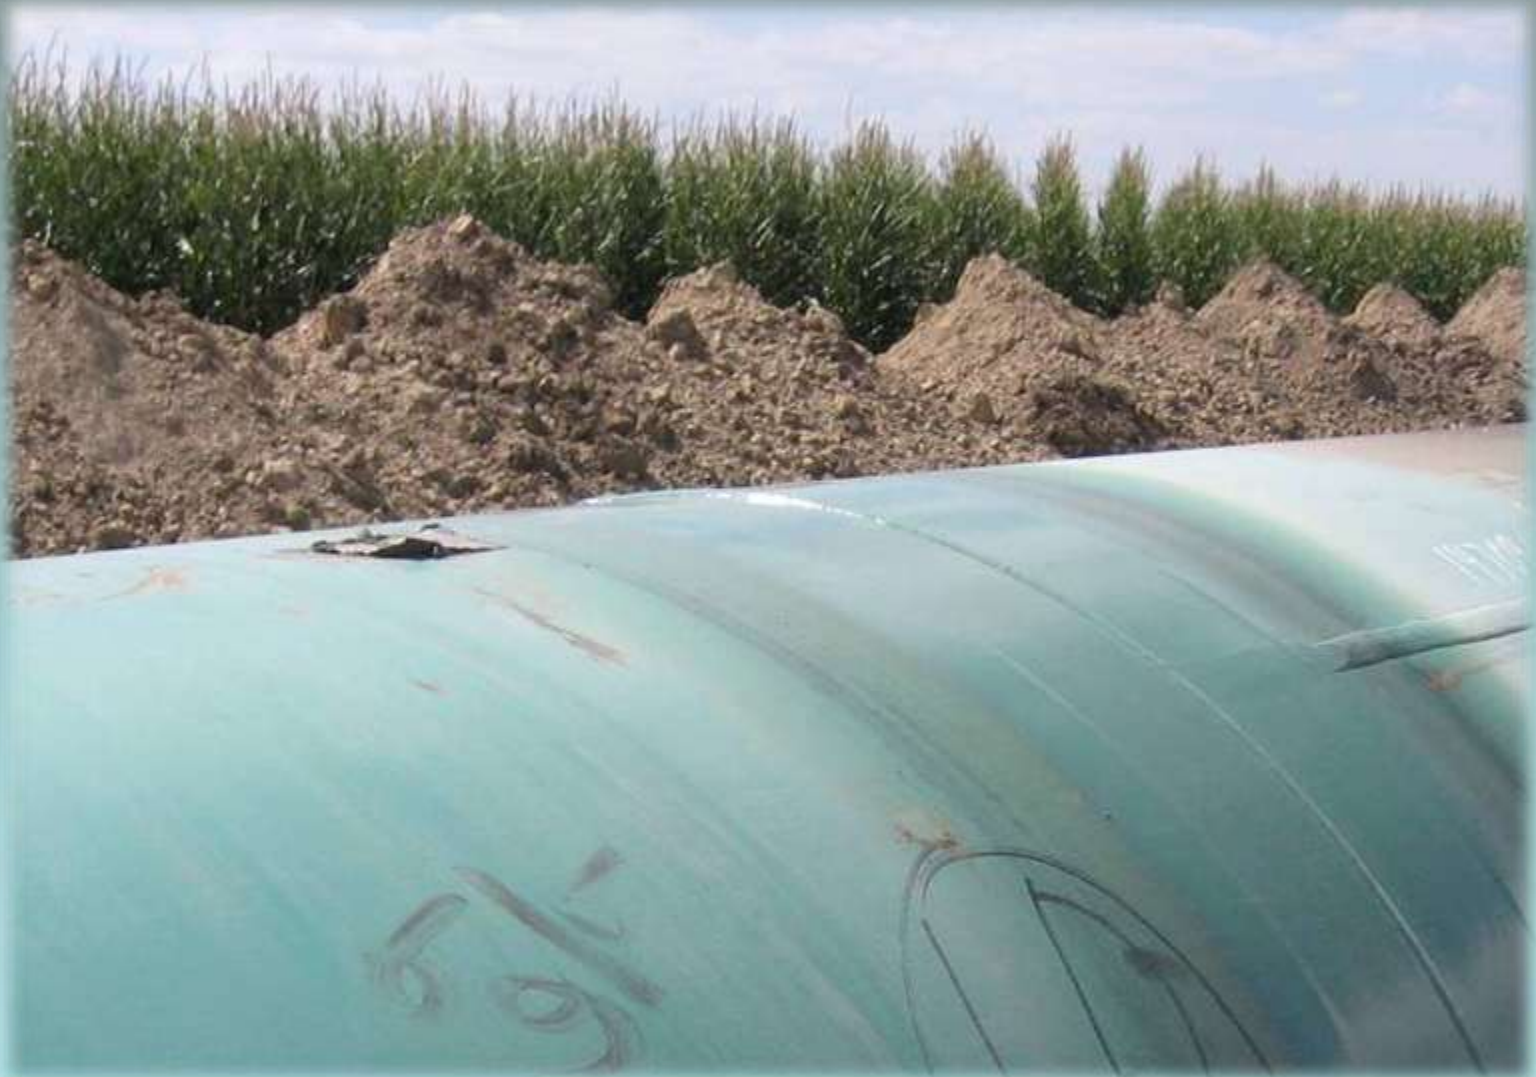
Duct tape can shield coating holidays

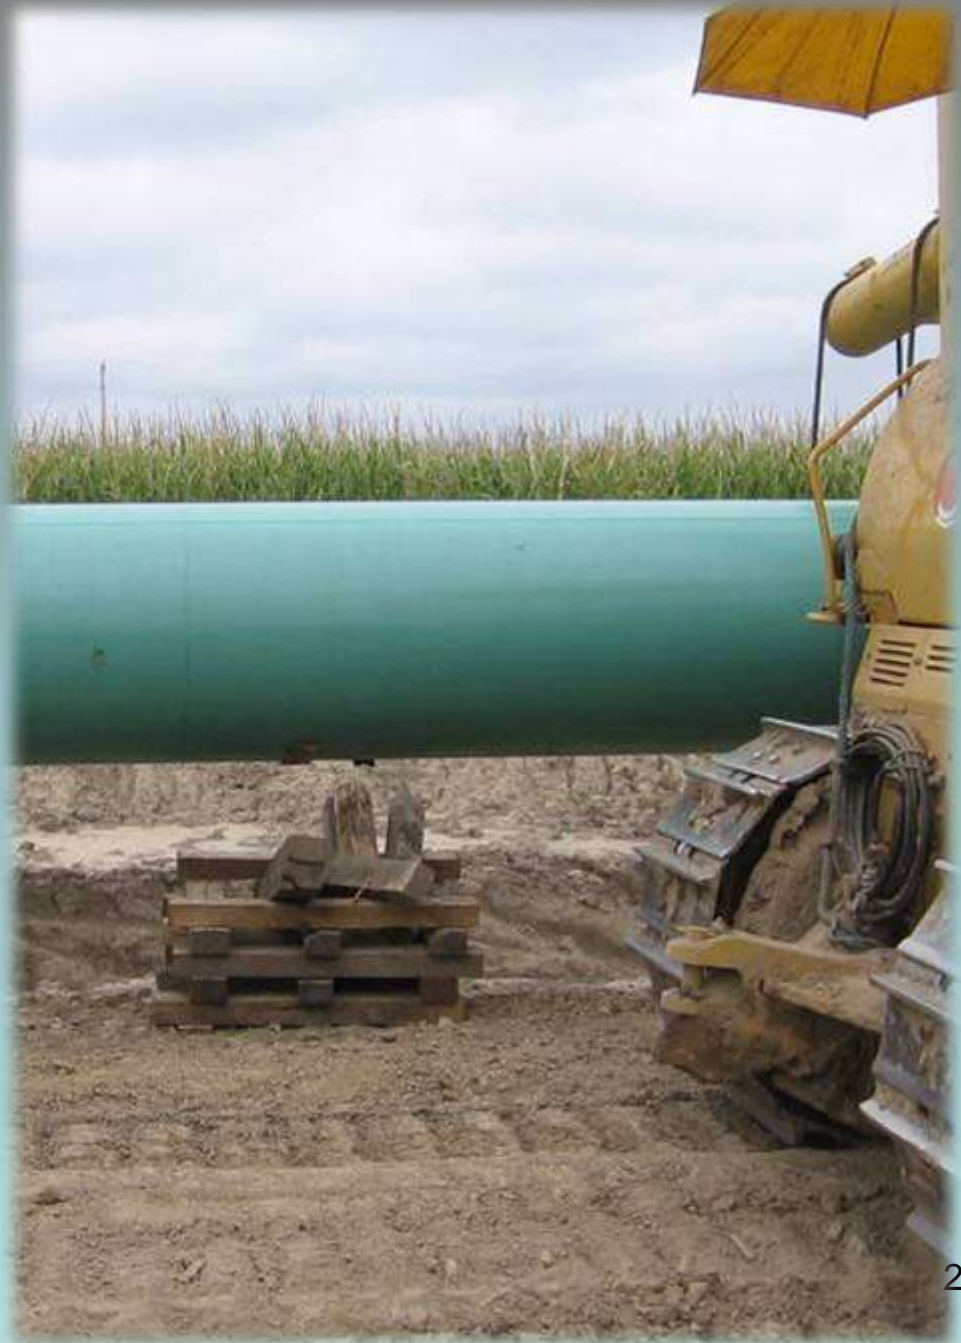
- Manipulating the jeep spring over building fiberboard stuck to the pipe is poor practice

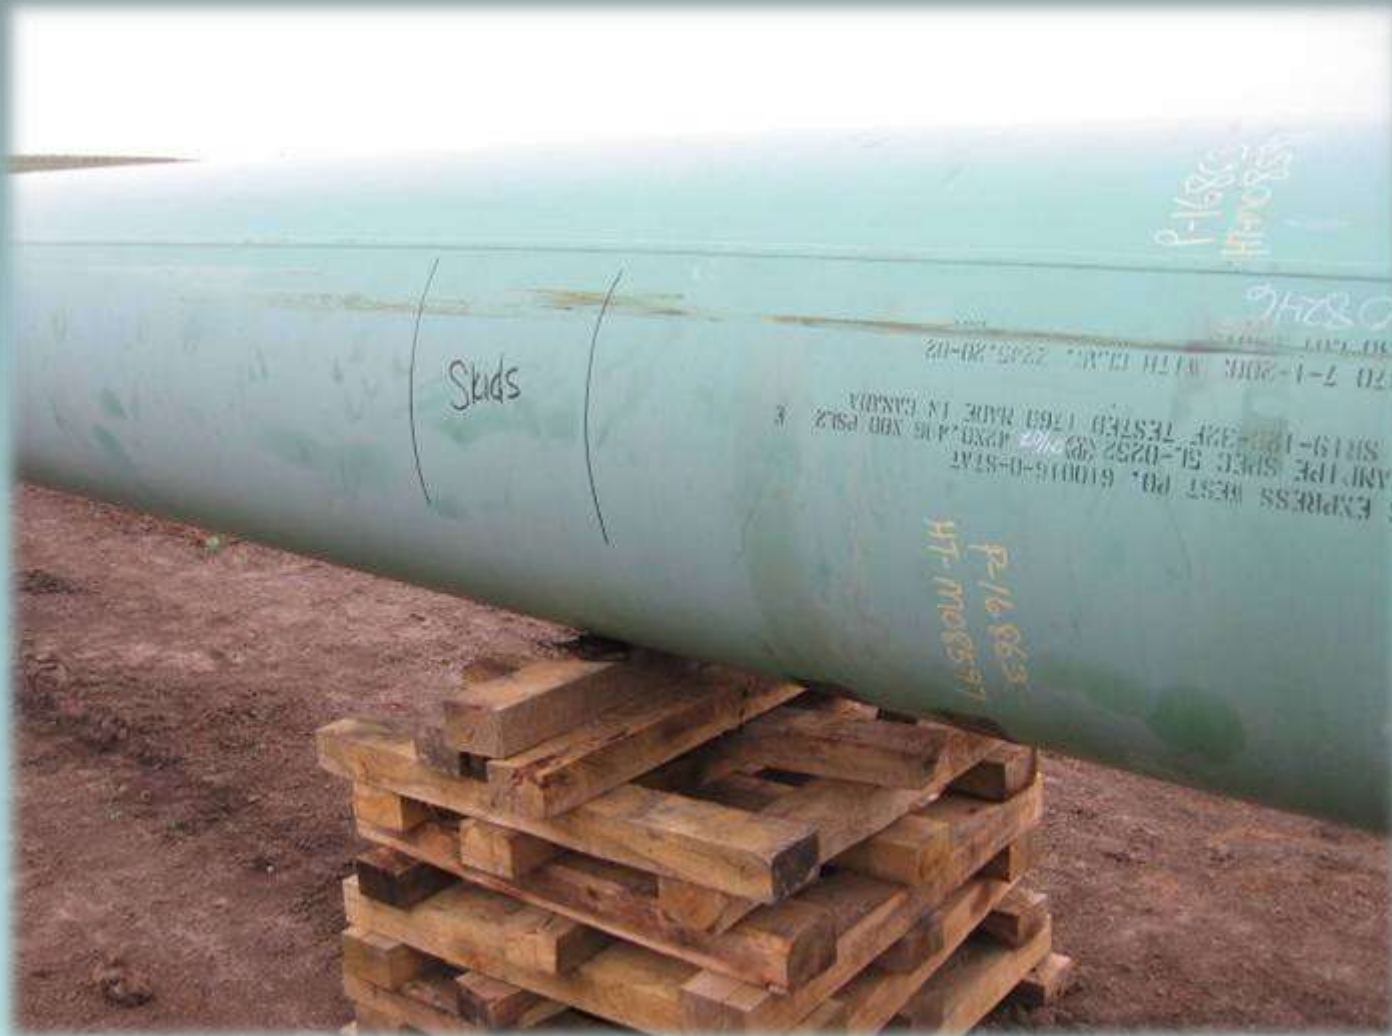
Just jeeping at skids only on lowering in is not usually per construction procedures

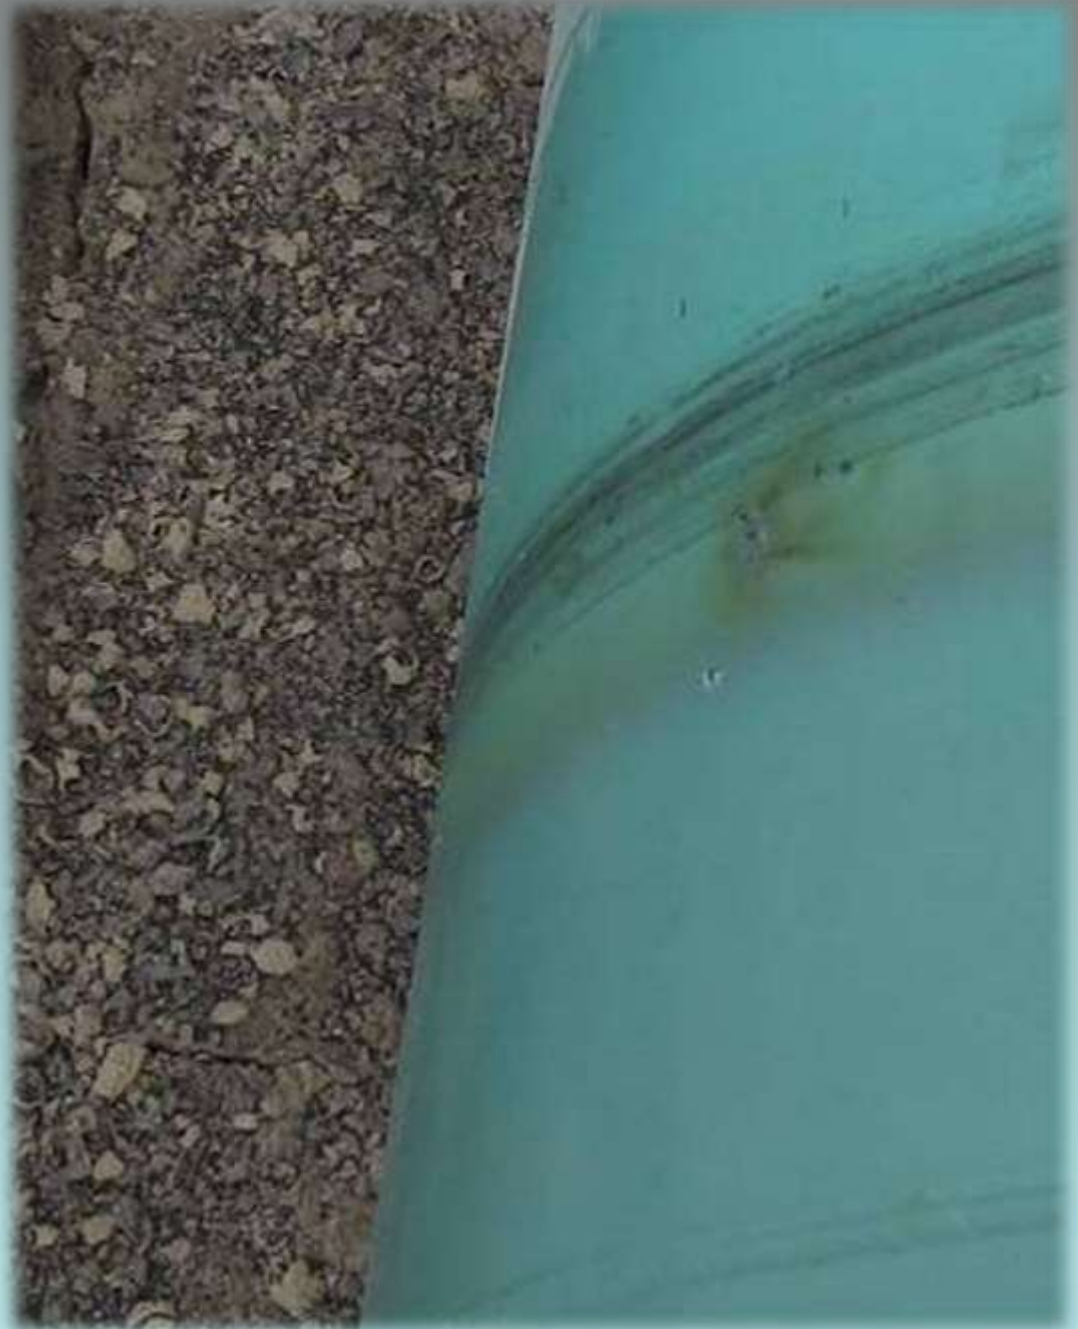
- Look for coating holidays in the ditch.
- Observing these indicates a problem.
